# Special Report 89-2

## *Response of pavement to freeze-thaw cycles*

*Lebanon, New Hampshire, Regional Airport*

Wendy L. Allen, William F. Quinn, Donald Keller and Robert A. Eaton

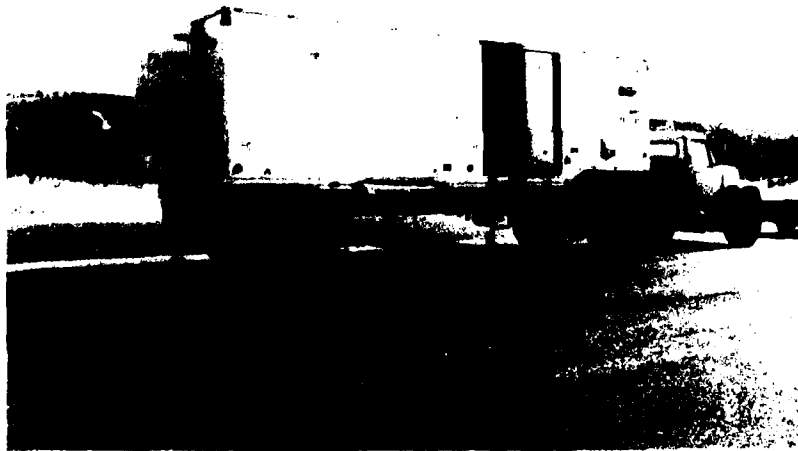
Figure 6. Repeated plate bearing test van.
